REHABILITATION OF DAMAGED SOFT GROUND TUNNELS

ABSTRACT

The paper presents the rehabilitation of soft ground tunnels that were damaged in an accident at the ventilation shaft A of the Pan-chiao Line of Taipei Rapid Transit Systems. Subsoil conditions and the preceding operations at the tunnel-shaft interface are introduced. The accident at shaft A is described and ground settlement data induced by the accident are presented. Procedures taken by the contractor during emergency rescue, damage assessment, and rehabilitation of shaft and tunnels are reported. Possible reasons that caused the accident included drift wood in the ground, cleavage between soilcrete and shaft, and non-verticality of grouting rods. It is concluded that the ground improvement outside the shaft before the shield's arrival played an important role in this accident. The geotechnical engineer should be extremely cautious when breaking the mirror-face on the diaphragm wall under the threat of high groundwater pressure.

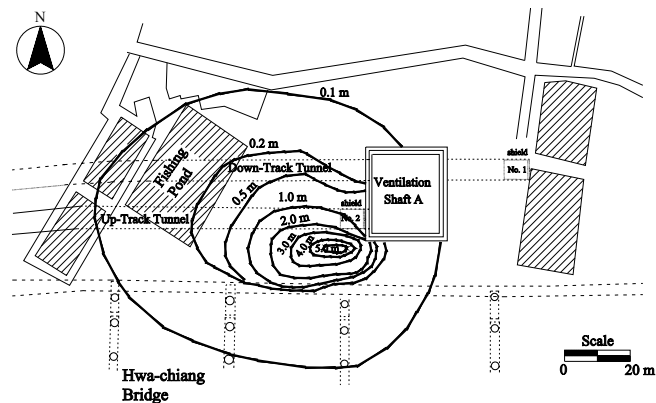
Fig. 5 Contours of ground settlement near ventilation shaft A (redrawn after Ju et al., 1997a)

The accident at ventilation shaft A occurred on July 16, 1995. Figure 5 shows, at that time, shield No. 1 for the down-track tunnel had departed shaft A and was advancing toward shaft B in Taipei City. Shield No. 2 for the up-track tunnel was waiting for its entrance into shaft A. The manual chip-off of the final 0.4 m-thickness of the diaphragm wall was in progress. Figure 6 shows, the lower-right corner of diaphragm wall was removed and the CJG soilcrete can be observed in the shaft.

The settlement cone shown in Fig. 5 was quickly filled with graded soils as indicated in Fig. 7. The total amount of fill used was about 4,850 m³.

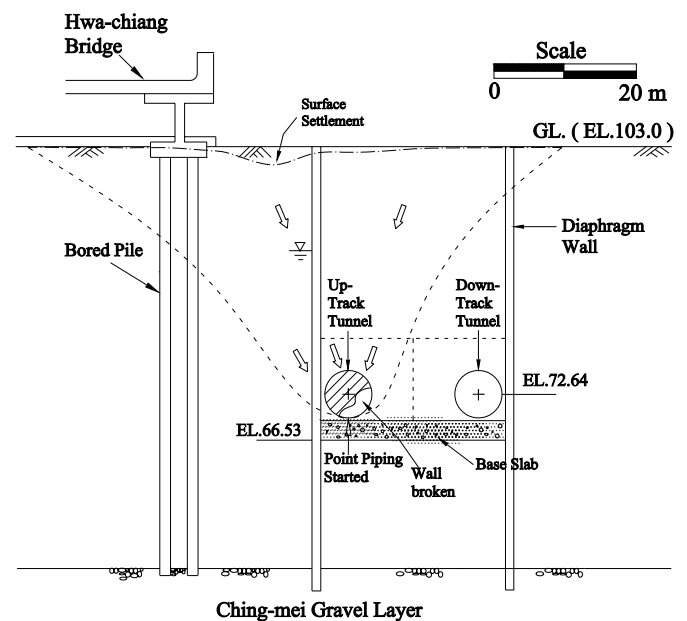
Fig. 6 Location of piping point and estimated ground movement

Unfortunately, at 1:30 a.m., large amount of groundwater leaked into the shaft at the up-track mirror-face at the 6-o'clock position as illustrated in Fig. 6. The initial rate of inflow was about 200 m³/hr, and increased to 400 ~ 700 m³/hr three hours later. The contractor tried to seal the groundwater inflow by piling up soil bags at the point of piping but in vain. Soils flowed into the shaft with intruding groundwater. The piping and associated loss of ground caused serious ground settlement near shaft A. The maximum surface settlement was about 5.0 m. The picture in Fig. 7 shows the significant ground subsidence near shaft A after the accident. The contours of ground settlement were illustrated in Fig. 5. The fishing pond indicated in Fig. 5 cracked and was badly damaged. Most importantly, the down-track and up-track tunnels already completed were severely damaged due to ground displacement and tunnel settlement.

In the up track tunnel, failure of the curved bolts between the lining segments was observed. Some segments shifted with each other. Groundwater seeped through the cracked lining segments. The tunnels and shaft were soon flooded, and finally both shield machines were submerged. For safety reasons, all personnel were evacuated from the submerged area. Flooding quickly expanded westward through the tunnels toward the crossover. At 4:30 a.m. of July 16, 1995, the depth of water in shaft A was about 2.5 m. Fortunately, the nearby Hwa-chiang Bridge was not severely affected because it was supported with pile foundations as indicated in Fig. 6.

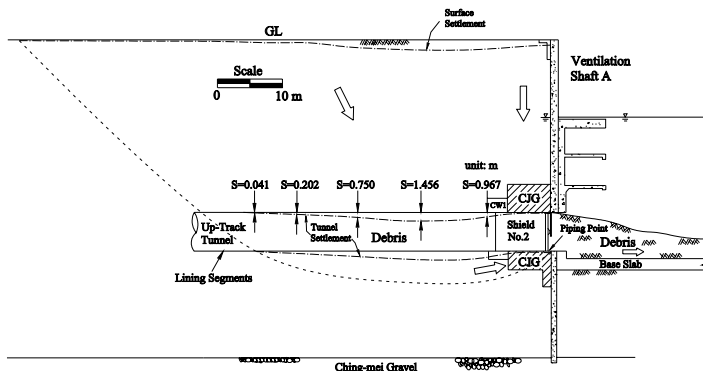
Fig. 8 Settlement of damaged tunnel and estimated ground movement

The settlement of the damaged up-track tunnel is illustrated in Fig. 8. The maximum measured settlement was 1.456 m. Shield machine No. 2 and its associated facilities were submerged and totally damaged. From ring 780 to 818, 39 lining rings were badly damaged and needed replacement. About 3,300 m³ of soils flowed into the tunnel and about 1,500 m³ of soils flowed into shaft A. The thickness of sedimentation in the shaft was indicated in Fig. 9. In the ventilation shaft, the submerged electrically, mechanical, communication and illuminating equipments were all seriously mutilated.

Based on the settlement curve of ground surface, settlement of damaged tunnel, and the location of the piping point, the longitudinal geometry of ground movement can be estimated as shown in Fig. 8. In the figure, the loss of ground at the piping point caused the soils under the tunnel to be eroded or even washed away. The tunnel and overburden soils subsided accordingly. The estimated transverse geometry of ground movement is indicated in Fig. 6. It is obvious that the surface settlement trough is not symmetrical with the up-track tunnel. Greater surface settlement was observed on the Hwa-chiang Bridge side. It is most probably that the wall friction between the diaphragm wall and soil helped to reduce the ground subsidence on the down-track tunnel side.

During the accident, large amount of groundwater and soils flowed into the tunnels and shaft. Figure 8 shows the up-track tunnel settled significantly because the soils under the tunnel were eroded or even washed away. If the voids and loose pockets in soils under the tunnel were not properly treated, during the following construction, the tunnel might settle more as a result of insufficient bearing capacity. Grouting holes were drilled at two sides of the tunnel down to the elevation of 69.0 m, which was the bottom elevation of the tunnel. The CB (cement + bentonite) grout injected under the damaged tunnel included 250 kg of Portland cement, 50 kg of bentonite, and 900 liter of water. Grouting operation was stopped when the injection pressure was 49 kPa (0.5 kgf/cm²) over the ground water pressure, which implied the soil voids were properly filled.

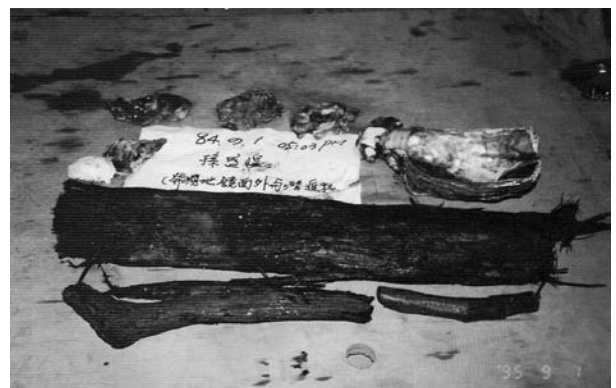
Fig. 16 Drift wood obtained between diaphragm wall and shield machine

Ventilation shaft A was constructed only 340 m from the river bank of Hsin-tien Creek. Shell fragments and organic matters were found in soil samples obtained from the alluvial deposits. Pieces of drift wood were observed in the CJG soilcrete chipped-off at the tunnel-shaft interface. The drift wood shown in Fig. 16 would block the high-pressure jet to cut native soils and might have adverse effects on ground improvement.
