STUDY OF AN UNSATURATED SLOPE FAILURE DUE TO RAINFALL INFILTRATION IN WENSHAN DISTRICT OF TAIPEI CITY

Horn-Da Lin¹, Jhih-Rou Huang^{2*}, Wei-Chien Wang³, and Chao-Wei Chen⁴

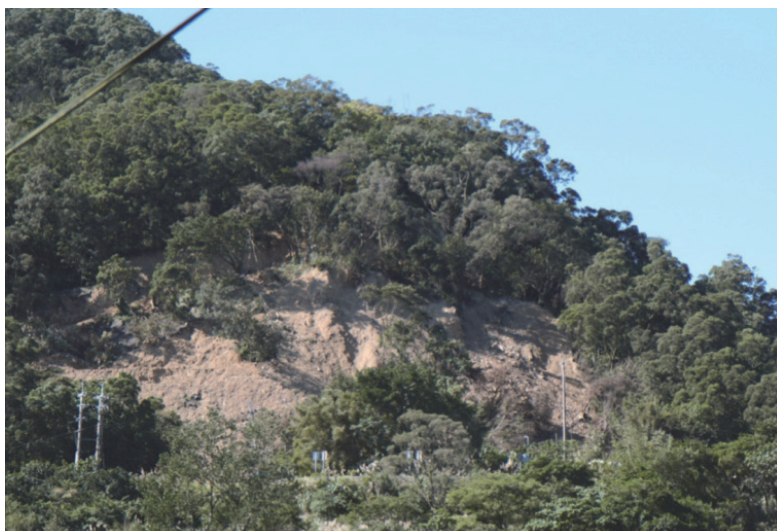
Fig. 3 The condition of the slope after the collapse (Land Engineering Consultants Co., Ltd. 2008)

In this case, the slope slid from southwest to northeast. The landslide area was 100 ~ 120 m wide and 100 ~ 150 m long. The total sliding area was approximately 1 ~ 2 ha. Furthermore, the landslide area is at the elevation of 180 ~ 240 m above sea level (Land Engineering Consultants Co., Ltd. 2008).

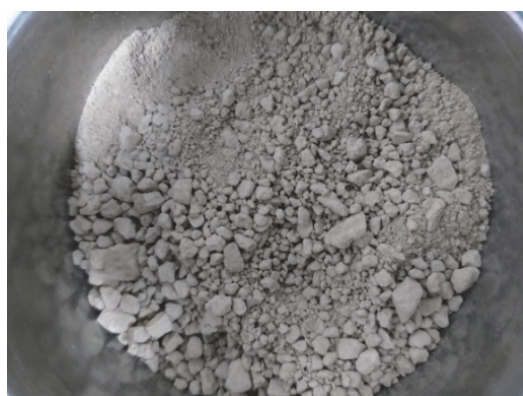
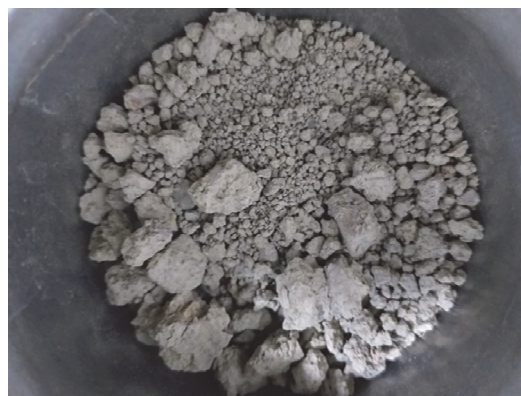
(a) Sample A

(b) Sample B

Fig. 4 Soil samples

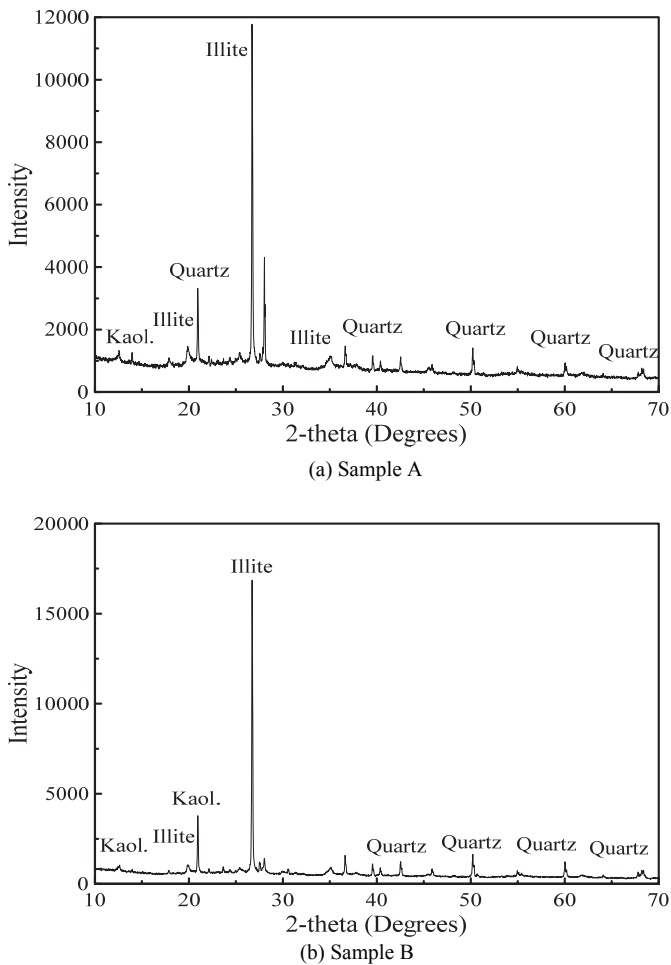
Fig. 5 Mineral composition of samples

The basic physical properties of these samples are summarized in Table. 1. The specific gravity and the Atterberg limits for this study were conducted according to ASTM D854-83 and ASTM D4318-10, separately. Additionally, the grain size distribution tests were done in accordance with ASTM D452-85. Two sets of soil samples are classified as CL (clay of low plasticity, sample A) and SC (clayey sand, sample B) respectively based on the Unified Soil Classification System (Fig. 4). In the results of X-Ray Diffraction (XRD) tests, sample A has 67% Illite and 10% quartz for the mineral composition. Sample B has 66% Illite and 18% Quartz for the mineral composition. That is to say, the principal minerals in these samples are similar which are Illite and Quartz (Fig. 5).

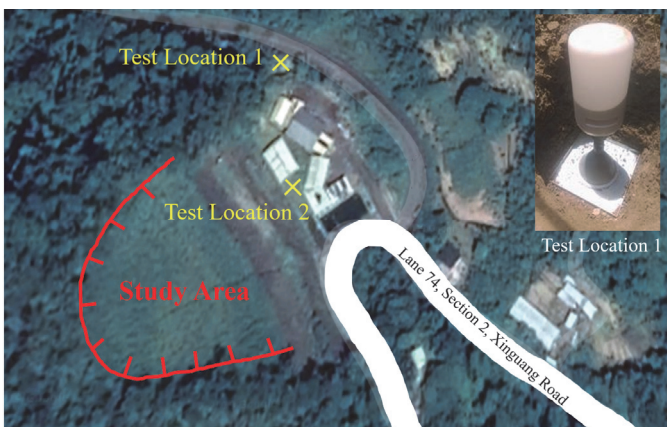
Fig. 6 Locations of sand-cone test (Google map)

The dry density and water content of the soils were measured using sand-cone tests to ASTM D1556 (Fig. 6). Thereafter, with a view to ensuring the uniform water contents of samples, the well-mixed soils were stored in zipper bags for 24 hours. The soils were then transferred to the mold and compacted by static pressure into a remolded specimen. The samples were 2 cm in height, and 5 cm in diameter. The weight of the mold was about 20 g.

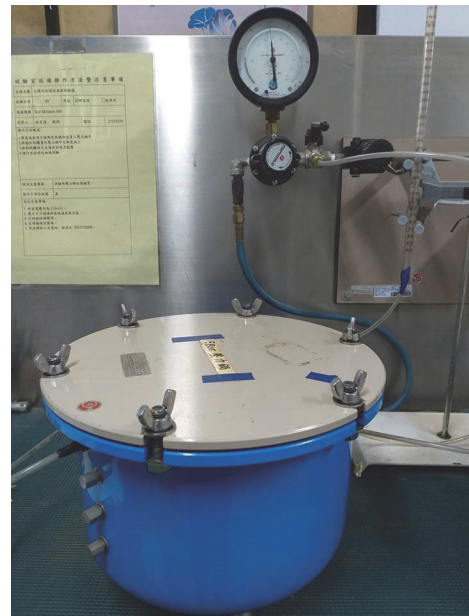
Fig. 7 Pressure plate equipment

The pressure plate test adheres to the ASTM D3152-72 standard to obtain the Soil-Water Characteristic Curve (SWCC). The pressure plate extractor of 500 kPa used in this study was made by Soilmoisture Equipment Corp (Fig. 7). It consists of a pressure vessel that is pressurized by nitrogen to a pressure of 500 kPa.

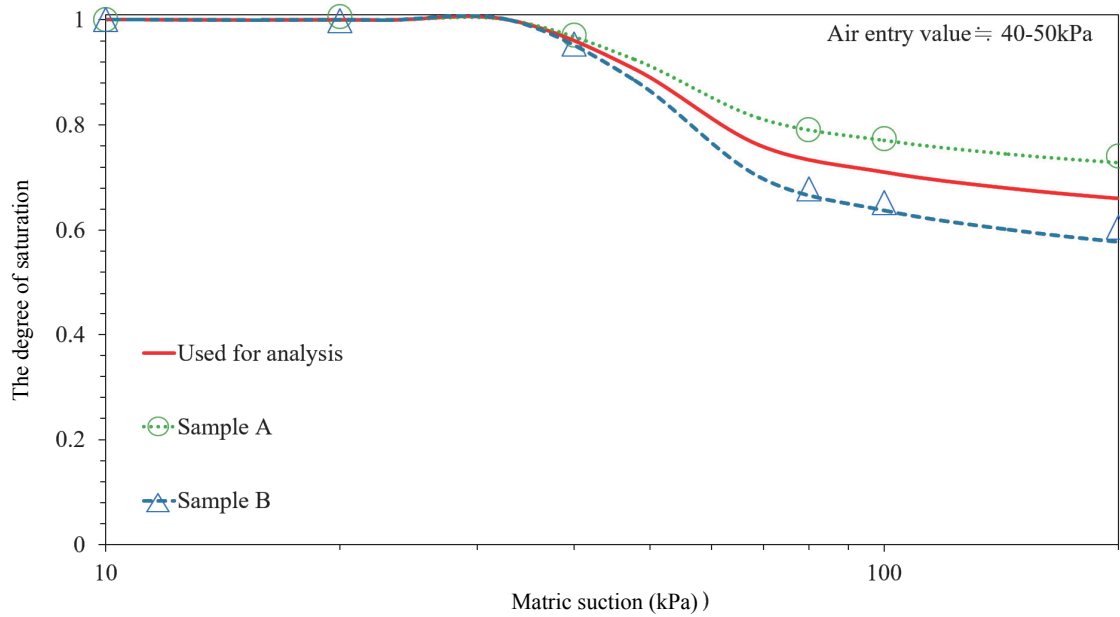
Fig. 8 Soil water characteristic curves (SWCCs) of colluvium

In this study, the soil water characteristic curve is obtained from the pressure plate test. The hydraulic conductivity curve (Fig. 9) is estimated using the saturated hydraulic conductivity and three curve fitting parameters (Van Genuchten 1980). The curve fitting parameters in Eq. (2) are calculated using the soil water characteristic curve. The k -function curve is derived from Eq. (2), Eq. (3), and Fig. 8. The k -curves for these two samples are shown in Fig. 9. Since the curves for sample A and sample B are close to each other, the red line (Fig. 9) is used in the analysis.

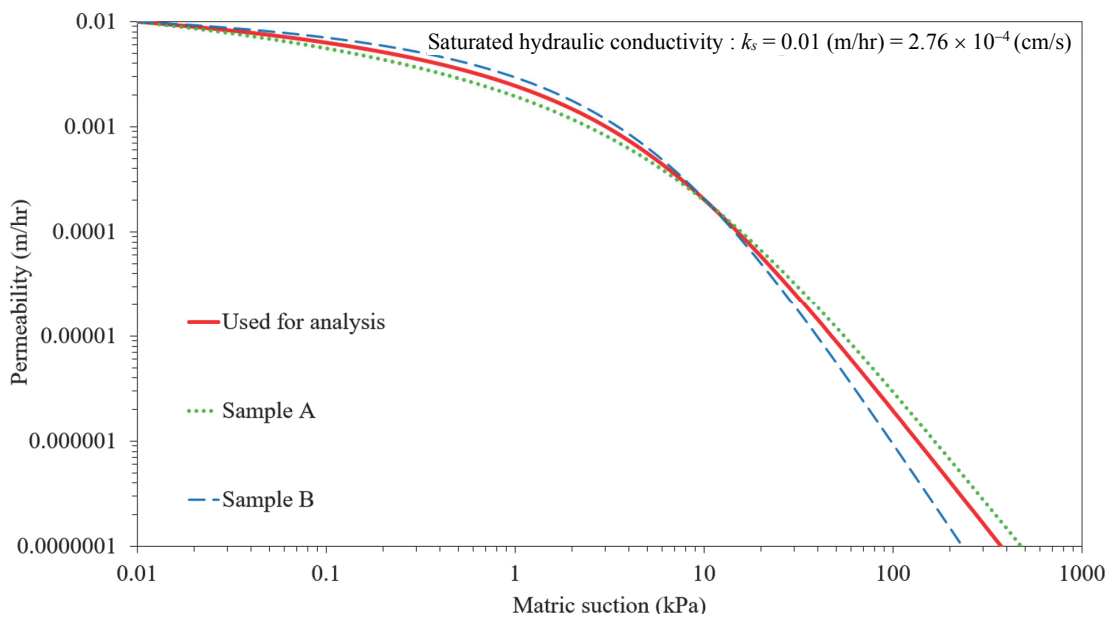
Fig. 9 Hydraulic conductivity function curves of colluvium

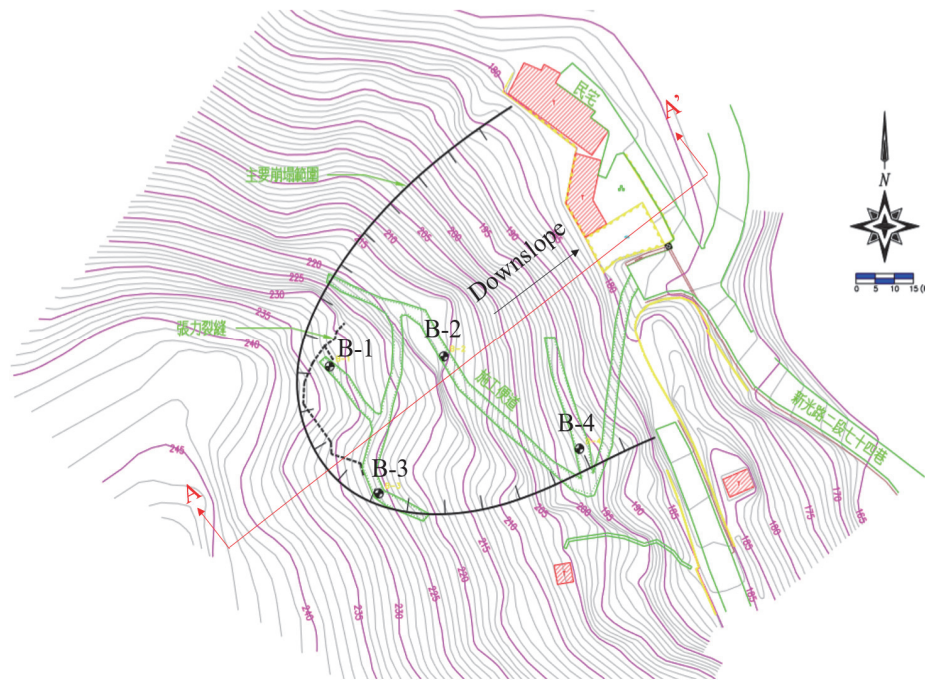
Fig. 10 Locations of boreholes and the section used in the numerical model (Land Engineering Consultants Co., Ltd. 2008)

The analysis uses the failure mechanism for the section in the middle of the collapsing area to represent the mechanism for the entire slope. Accordingly, section A-A' (Fig. 10) is utilized for the numerical model (Fig. 11). The properties of the soil and the information regarding groundwater within the slope were attained from in-situ and laboratory tests during the site investigation by Land Engineering Consultant Co. Ltd. The locations of boreholes are shown in Fig. 10, and the detailed material properties are listed in Table 2.

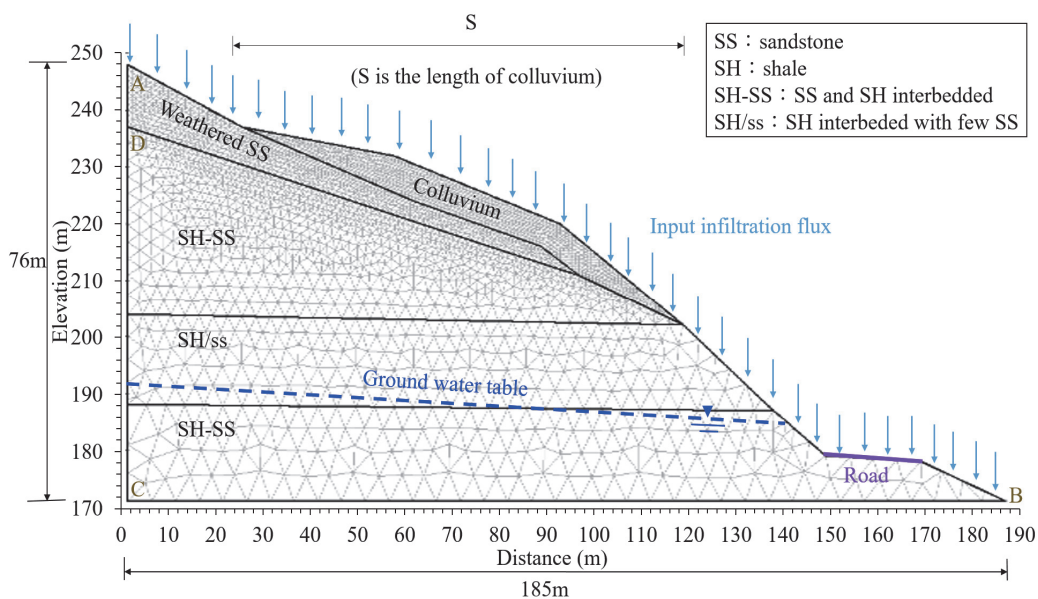
Fig. 11 Numerical model and boundary condition

The geometry of the slope is constructed based on the topographic maps and the soil profiles are interpolated from boreholes (Land Engineering Consultants Co., Ltd. 2008). Figure 11 shows the cross-section of the slope. The average slope angle of the slope is 22°. The upper layer of the slope is colluvial soil that is 1 to 8 meters deep. Below the colluvium, there is weathered sandstone, sandstone-shale interbedded layer (SH-SS) and shale interbedded with some sandstone (SH/ss).

The height of the section is approximately 76 m, and the width is about 185 m. As shown in Fig. 11, the numerical model is composed of triangular elemental meshes. Elemental meshes of different densities are used to ensure accurate analysis and to reduce the computational time. Colluvium is the most susceptible part of the whole slope to variations in moisture under infiltration. Fine elemental meshes are used for the colluvium, but thick element meshes are used for the rock layers.

The two lateral ends are set to be constant head boundaries in accordance with the groundwater table initially. During the analysis, downward vertical flux is utilized on the surface of the slope to stimulate infiltration. To elaborate, the input values of downward vertical flux are obtained from the hourly actual rainfall data. Nevertheless, evaporation, prescribed in upward vertical flux, is not considered during rainfall due to high humidity. Owing to low hydraulic conductivities of rocks, boundaries BC and CD were set to be total flux $Q = 0$ m³/hr. In addition, the boundary AD for weathered sandstone was seepage boundary to enable water flow (Fig. 11).

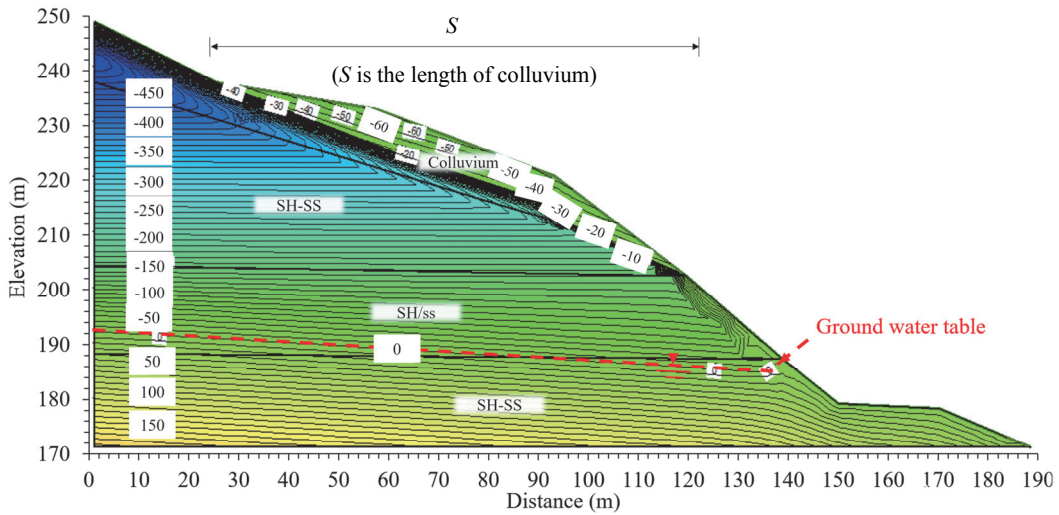
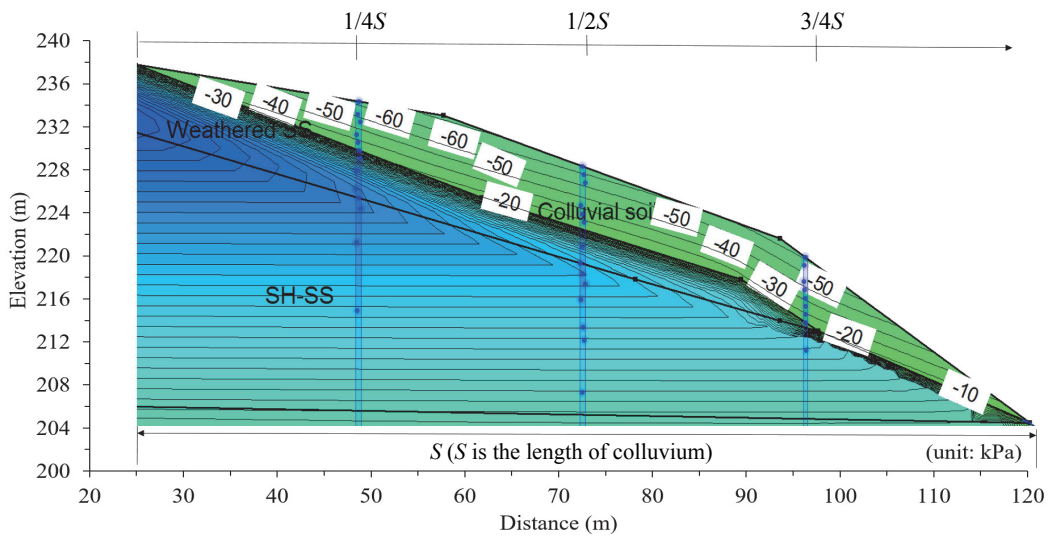
Fig. 12 Contour for the initial pore water pressure (Duration = 0hr, FS = 1.321)

The approach to simulate antecedent hydrological conditions for the subsequent hydrological events has been described by Blake et al. (2003), Oh and Lu (2015), and Qi and Vanapalli (2015). The initial pore water pressure was simulated by conducting a transient seepage analysis. A small flux was specified on the surface of the slope for a long period of time until the pore water pressure reached steady state. Ultimately, the initial pore water pressure within the colluvium was -60 to -10 kPa (Fig. 12 and Fig. 13).

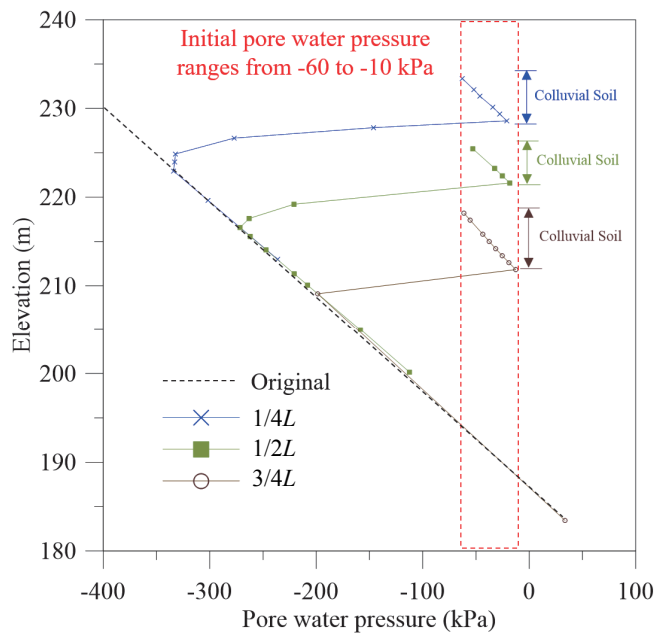
Fig. 13 Initial pore water pressure

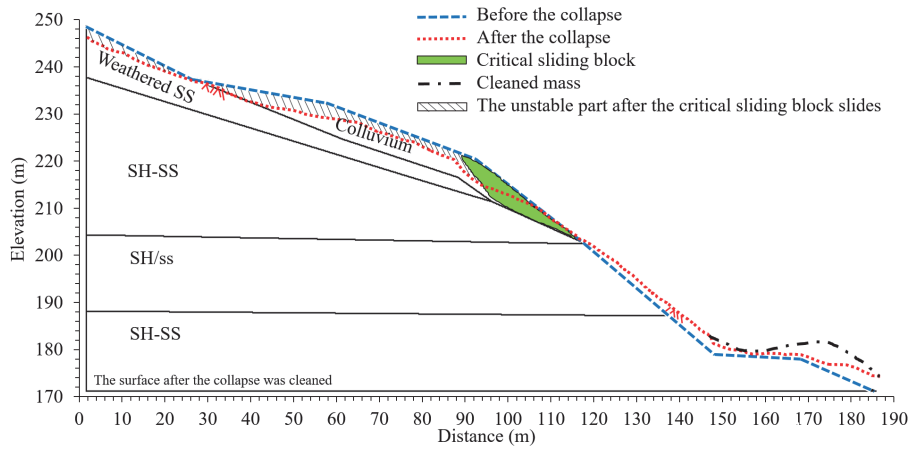
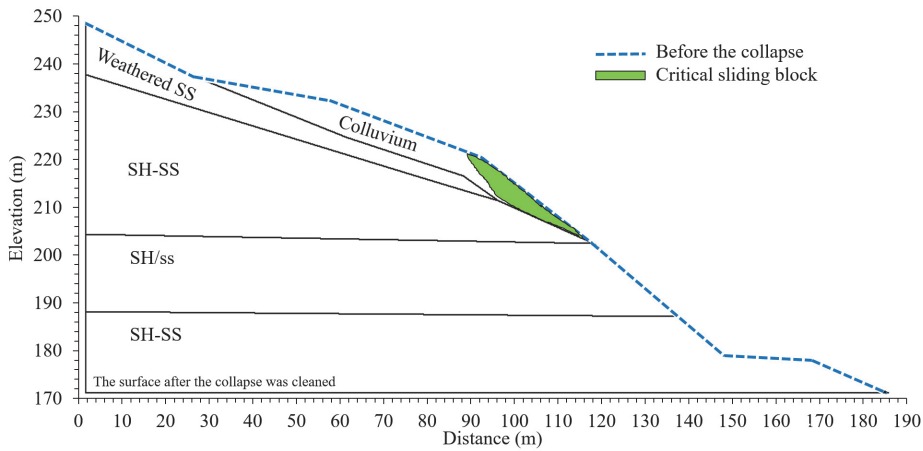
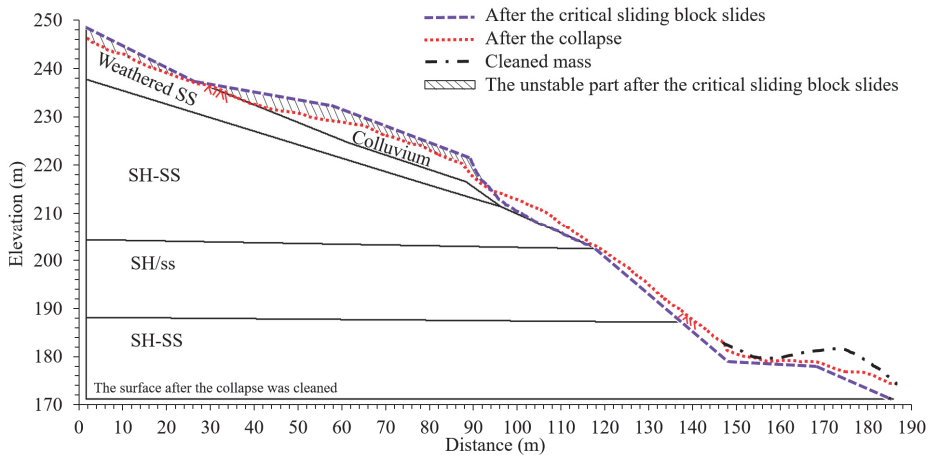
(a) Topographic maps before and after the collapse and the location of the critical sliding block.

(b) Before the slope collapses

(c) After the critical sliding block slides

Fig. 14 Topographic maps

A comparison of the topographical maps before and after the collapse reveals that the primary failure mechanism for this case is a shallow collapse, shown in Fig. 14(a). Figure 14(b) shows that the critical sliding block is in the lower part of the colluvium. After the critical sliding block slides, the critical sliding block is removed in Fig. 14(c) (the purple line). By the comparison of the purple (the topography after the critical sliding block slides) and the red line (the topography after the failure of the slope). It is expected that after the initial slide the upper part of the slope (the area with slashes) became unstable and slid down progressively as displayed in Fig. 14(c).

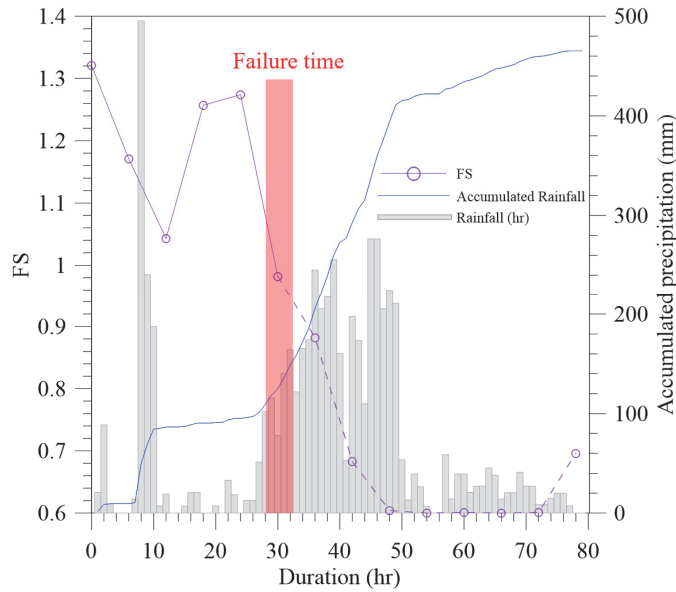
Fig. 15 Variation of FS during rainfall infiltration

Overall, the factor of safety decreases when the infiltration increases. During the beginning of the rainfall for 12 hr, the factor of safety decreases with the heavy rainfall. However, from 12 hr to 24 hr, the amount of rainfall becomes light. Because the thickness of the colluvium is thin, the water flows away and dissipates easily. Hence, the value of FS increases. Then, precipitation increases after 24 hr. Consequently, the factor of safety decreases and is about 1.0 at 30 hr (Fig. 15), which is consistent with the statements of residents.

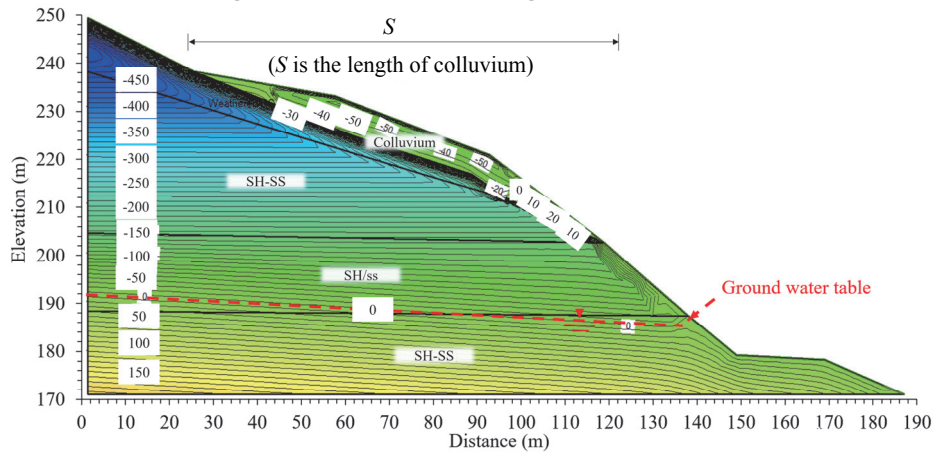
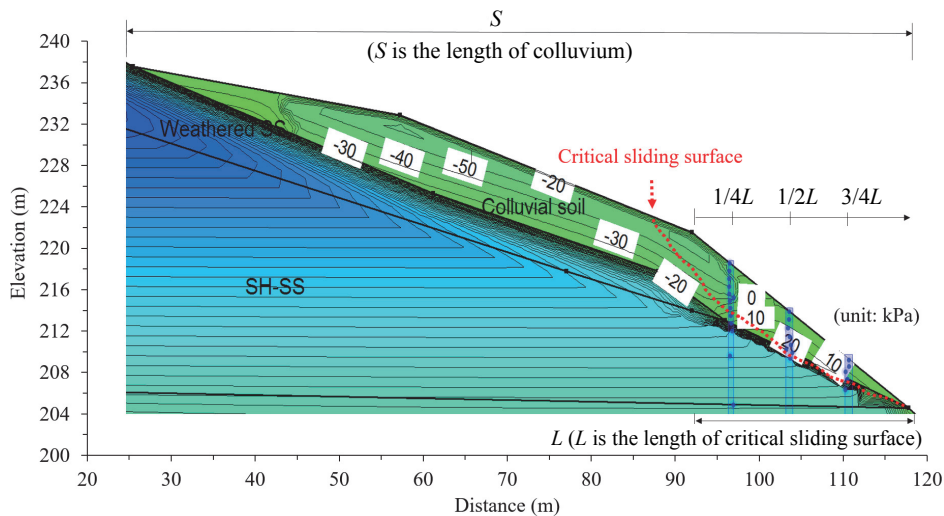
Fig. 16 Pore water pressure (kPa) contours. (Duration: 30hr, FS = 0.98)

Figure 17 depicts the variation in the pore water pressure for three sections (Fig. 16) within the critical sliding block during infiltration. Initially, the pore water pressure for section 1/4L is -60 to -10 kPa, for section 1/2L is -40 to -10 kPa, and for section 3/4L is -30 to -10 kPa. After 30 hours of rainfall, the pore water pressure for section 1/4L is -40 to 20 kPa, for section 1/2L is 0 to 40 kPa, and for section 3/4L is 0 to 25 kPa.

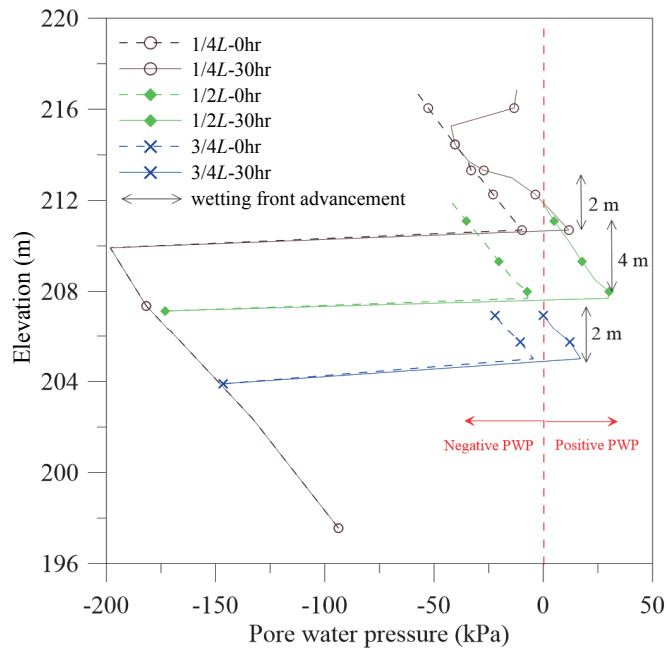
Fig. 17 Variation of pore water pressure during rainfall infiltration (Duration: 30hr, FS = 0.98)

result, the primary failure mechanism for this slope is the development of the advancing wetting front. Fig. 17 shows that when the slope fails, the depth of the rainfall-induced wetting front is greater than 2 m.

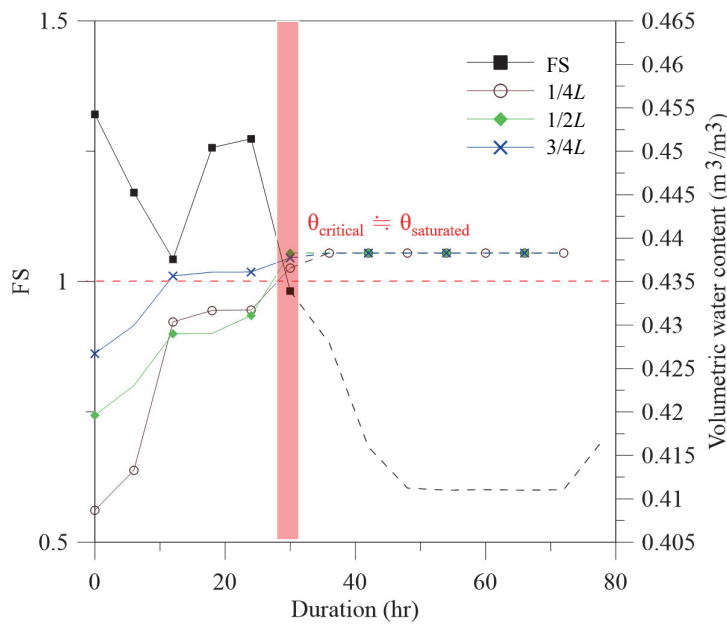
Fig. 18 Variation of FS and critical volumetric water content during rainfall

Sections of $1/2L$ and $3/4L$ are fully saturated. The result indicates the complete loss of matric suction and the development of positive pore water pressure in these two sections, as the slope collapses. At this time, the critical volumetric water content is equal to the saturated volumetric water content (Fig. 18). As a
