# FIELD PERFORMANCE OF A HYBRID REINFORCED EARTH EMBANKMENT BUILT ADJACENT TO A SLOPE WITH NARROW FILL SPACE

## ABSTRACT

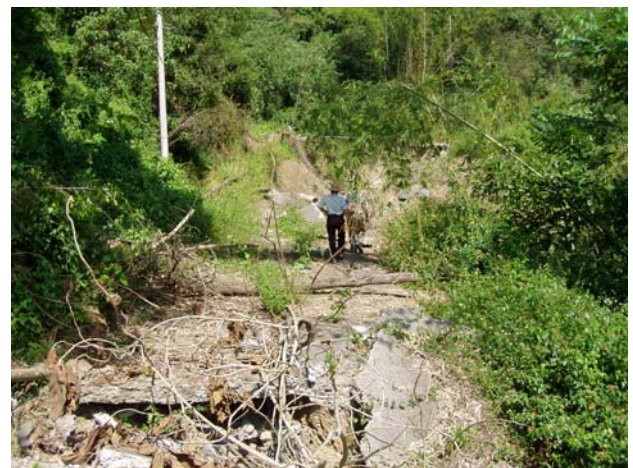
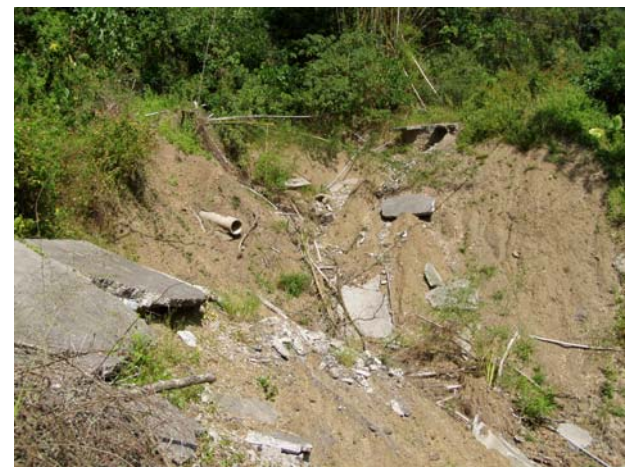
**Fig. 3** Collapse of a mountainous roadway at Liouguei, Kaohsiung City, Taiwan

The site of the research project is located at Liouguei in Kaohsiung city, Taiwan, as shown in Fig. 2. The project site is about 1.5 km north of downtown of Liouguei. The width of the mountain roadway is 4 ~ 5 m. The slope gradients of the upslope and downslope of the roadway are about 30° ~ 50° and 25° ~ 40°, respectively. This roadway collapsed in the summer of 2005 due to the attack of several Typhoons. The retaining structure supporting the roadway embankment prior to the collapse was reinforced concrete retaining walls. The length of the collapse roadway was about 100 m. The photos of the collapsed roadway are shown in Fig. 3. The roadway runs across a gullied slope. This location was severely damaged due to the heavy rainfall in 2005. The embankment of the collapsed mountain roadway was located on a concave section. The surface runoff collected in the concave section imposed a high water pressure on the back of the wall and

softened the backfill material. In addition, the downslope of the embankment was steep and subject to erosion in rainy season. The poor drainage system in the retaining wall was regarded as the major reason blamed for the failure of the roadway embankment.

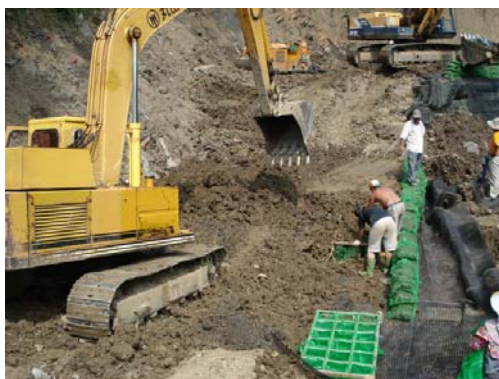
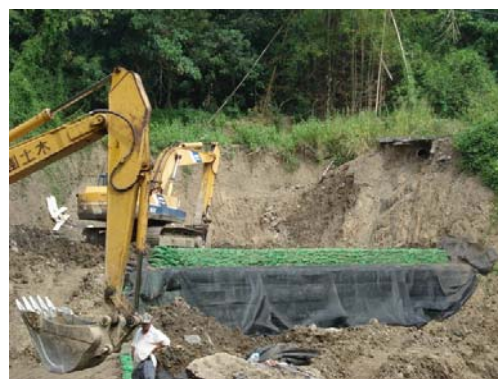
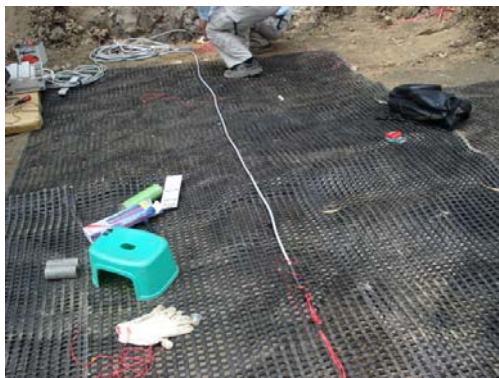
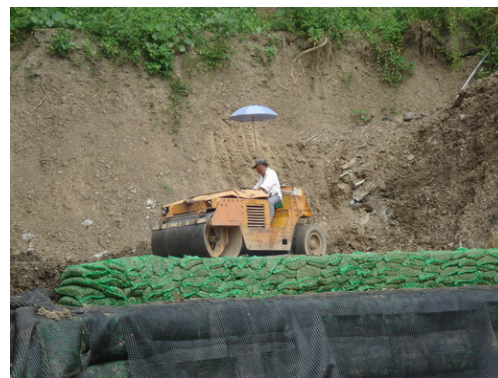
(a) Building embankment facing

(b) Backfilling

(c) Installation of reinforcement placed with strain gages

(d) Compaction

Fig. 6 Construction of the hybrid reinforced earth embankment at the experimental site

Extensible PET geogrids with tensile strength of 150 kN × 75 kN (Seven-state Inc.) were used for the reinforcing material, and soil nails used were #10 rebar (32 mm in diameter) surrounded by 10 cm diameter ring of cement mortar. Stainless steel wire ropes, connecting elements, were used to connect soil nails and reinforcing materials by binding the nail's head and the steel pipe. At least a pair of stainless steel wire rope clips is used to tie the stainless steel wire rope at both ends. The diameter of the Stainless steel wire rope was about 0.016 m. The backfill material consisted mainly of silty materials mixed with sands. The degree of compaction for the backfilling was required to be greater than 90%. Typical design cross-section of the hybrid reinforced earth embankment is shown in Fig. 5. Construction of the hybrid reinforced earth embankment is demonstrated in Fig. 6. The slope adjacent to the roadway embankment was excavated and trimmed before soil nails can be installed, followed by the construction of the reinforced earth embankment. Figure 7 shows the completed embankment at the experimental site.

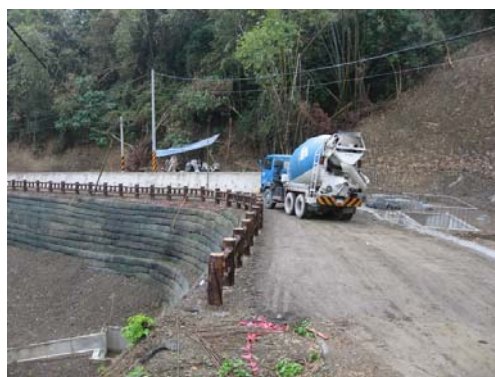
Fig. 7 The completed embankment at the experimental site and subjected to traffic loading

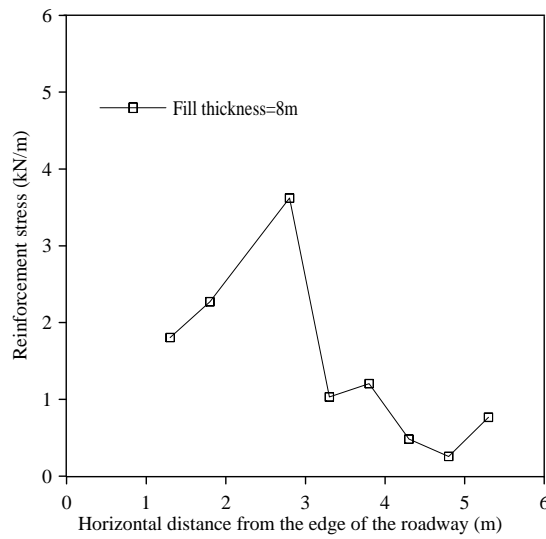
Fig. 8 Distribution of reinforcement (geogrid) stresses and nail forces of the embankment during the construction

Fig. 8 Distribution of reinforcement (geogrid) stresses and nail forces of the embankment during the construction (continued)

Figure 8 shows the monitored distribution of reinforcement (geogrid) stresses at depths of 5.5 m, 4.5 m, 3.5 m, 2.5 m, 2 m, 1.5 m, and 1 m below the top of the embankment during the construction. Most of the reinforcement stresses were developed at about 2 ~ 4 m from the edge of the roadway. The reinforcement stresses were mobilized partly due to the weight of the fill, in addition, the construction loads induced by trucks, backhoes, and smooth-wheel rollers also contribute considerably to the mobilization of reinforcement stresses.

The maximum reinforcement stresses at various elevations following the construction reach to about 2 ~ 4 kN/m, and the maximum reinforcement stresses occurs at about 1/2 to 2/3 reinforcement length away from the edge of the roadway. The maximum reinforcement stress following the construction of the embankment reaches to about 4 kN/m and takes place at a depth of 4.5 m below the top of the embankment, and this reinforcement stress corresponds to a tensile strain of about 0.33%. Field measurements on reinforced earth walls (Simac *et al.* 1990; Allen *et al.* 1992) showed that reinforcement strains were in the range of 0.1% to 0.5%, and most of the strains occurred during the construction stage. These observed results are close to those obtained in the research.

In addition, distribution of the tensile forces along the depth developed in soil nails at depths of 5.5 m, 4.5 m, 3.5 m, 2.5 m, 1.5 m, and 1 m below the top of the embankment during the construction is also shown in Fig. 8. The maximum nail force at different elevations during the construction is mobilized at the head, and the tensile forces fade away along the length of the nail. The mobilized nail forces comply with the mechanism of the stress distribution of the embankment system, *i.e.* soil nails provide extra resisting forces which the reinforced earth embankment needs to reach a safe condition. The nail forces at the depth less

than 2 m are minor, and the maximum nail force reaches to about 22 kN. The maximum nail force along the depth takes place at a depth of 4.5 m, and the value is 160 kN.

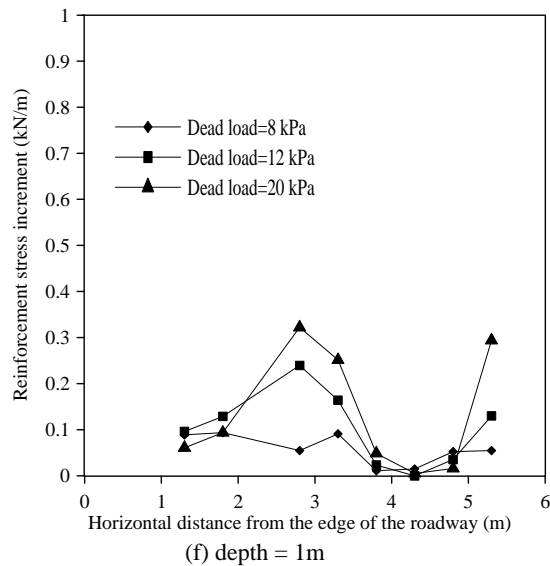
**Fig. 10** Distribution of reinforcement (geogrid) stress increment and nail force increment of the embankment under static loading

Fig. 10 Distribution of reinforcement (geogrid) stress increment and nail force increment of the embankment under static loading (continued)

Static loads of 8 kPa, 12 kPa, and 20 kPa, induced by 8-ton, 12-ton, and 20-ton backhoe on a  $10 \text{ m}^2$  metal plate with a thickness of 0.15 m, were applied on the top of the embankment roadway following the construction of the embankment. The monitored strains in reinforcements and soil nails were transformed into stresses and forces, respectively. Figure 10 shows the distribution of reinforcement (geogrid) stress increment and nail force increment at depths of 5.5 m, 4.5 m, 3.5 m, 2.5 m, 2 m, 1.5 m, and 1 m below the top of the embankment under static loading. The static loading has a considerable influence on the reinforcement stress increment at a depth less than 1.5 m. The maximum reinforcement stress increment was 0.3 kN/m for the reinforcement at a depth of 1 m, corresponding to a strain increment of 0.026%. The maximum reinforcement stress induced at a depth of 1 m following the construction of the embankment was 3.6 kN/m, corresponding to a strain of about 0.3%. The 20-kPa static loading on the roadway results in an increase of 8.3% in the reinforcement stress with respect to that following the construction.

Additionally, distribution of the tensile force increment mobilized in soil nails along the length at depths of 5.5 m, 4.5 m, 3.5 m, 2.5 m, and 1.5 m below the top of the embankment under static loading is shown in Fig. 10. The maximum increment in the nail force increases with the depth, and it ranges from 12 kN to 30 kN. The reinforcement stress increment and nail force increment increases with the quantity of the loading at various depths.

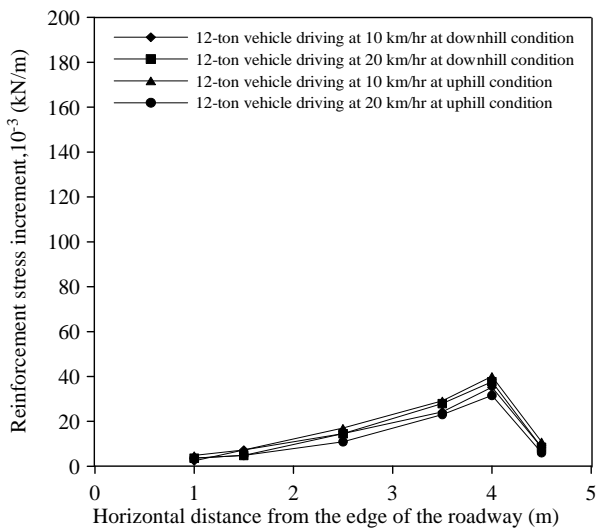
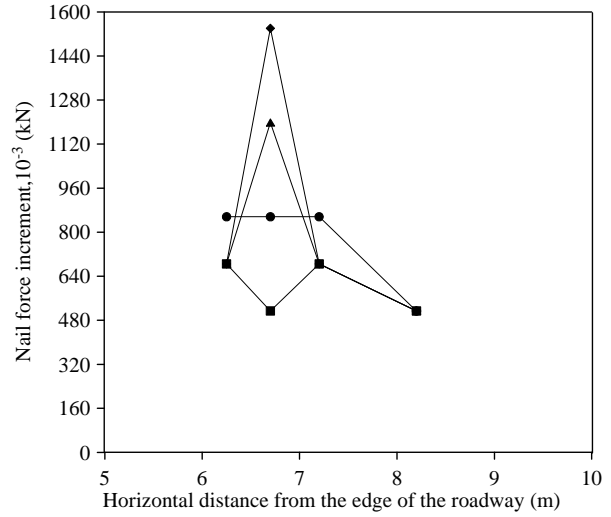
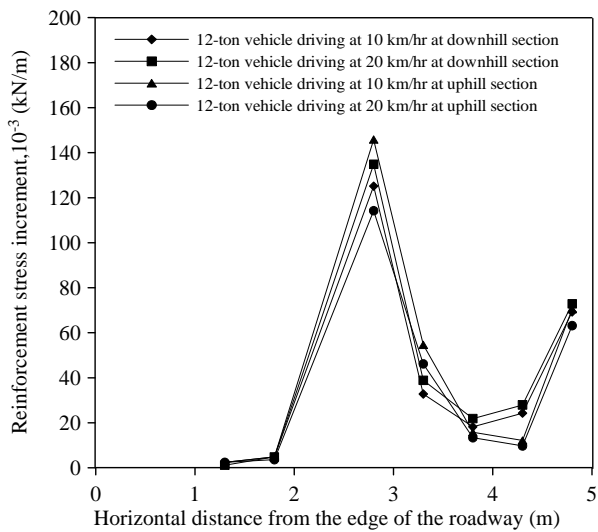
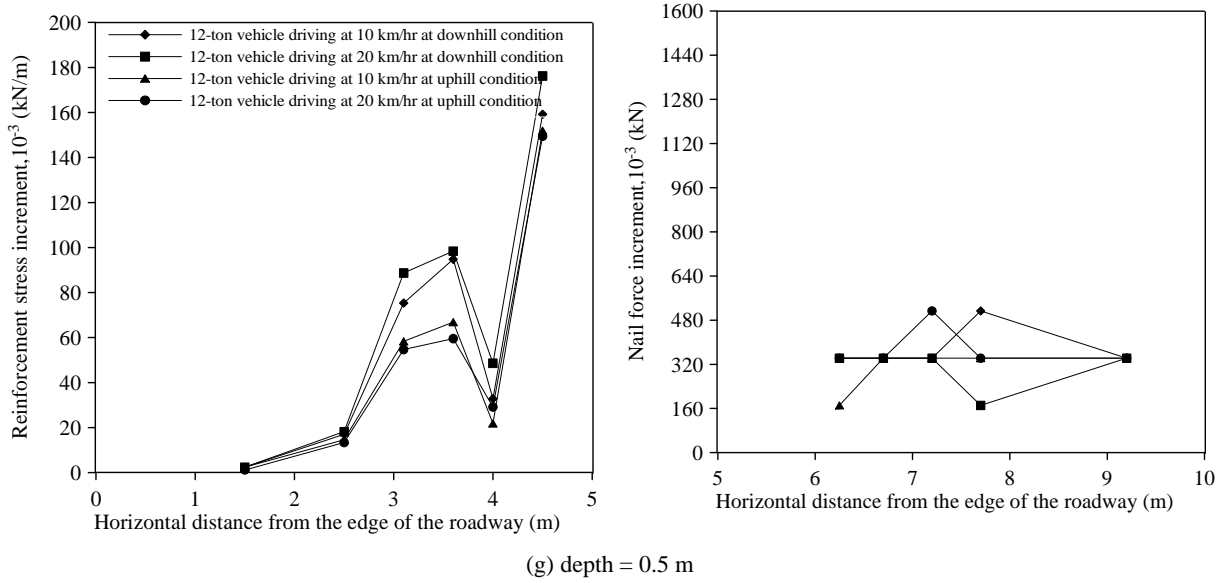
Fig. 11 Reinforcement (geogrid) stress increment and nail force increment within the embankment subjected to 12-ton moving vehicle

**Fig. 11 Reinforcement (geogrid) stress increment and nail force increment within the embankment subjected to 12-ton moving vehicle (continued)**

Fig. 11 Reinforcement (geogrid) stress increment and nail force increment within the embankment subjected to 12-ton moving vehicle (continued)

Shown in Fig. 11 is the monitoring result of tensile stress increment on the 12-ton concrete mixer truck driving through uphill and downhill conditions at a speed of 10 km/hr and 20 km/hr. The results at a depth of 4.5 m, 3.5 m, 2.5 m, 2 m, 1.5 m, 1 m and 0.5 m from the road surface are presented.

The test results show that there is no significant impact on driving speed towards reinforcement stress increment. The tensile stress increment on reinforcements decreases with increasing depth. The reinforcement within 1 m below the road surface developed a greater tensile stress increment compared with that at depth below 1 m. At downhill conditions, the maximum stress increment on the reinforcement at 0.5 m below the road surface occurred at the end section of the reinforcement with a value of about 0.18 kN/m, while the maximum stress increment on the reinforcement at 1 m below the road surface occurred at the central portion of reinforcement with a value of about 0.14 kN/m. The maximum stress increment on reinforcements within 1 m below the road surface is about 0.4 ~ 0.6 kN/m for the embankment under 20-kPa static loading. The tensile stress increment on reinforcement caused by traffic loading of the 12-ton concrete mixer truck is about 30% of that induced by 20-kPa static loading. The maximum force increment on soil nails in various depths caused by the 12-ton vehicle driving through downhill conditions falls roughly within 0.48 ~ 1.44 kN.

In addition, at uphill conditions, the maximum tensile stress increment on the reinforcement at 0.5 m below the road surface occurred at the end section of reinforcement with a value of about 0.15 kN/m, while the maximum tensile stress increment on the reinforcement at 1.0 m below the road surface occurred at the central portion of the reinforcement with a value of about 0.14

kN/m. The tensile stress increment on the reinforcement caused by the 12-ton vehicle driving through uphill conditions is about 25% ~ 30% of that induced by 20-kPa static loading. In addition, the results under uphill and downhill driving conditions of the 12-ton vehicle have no significant variance towards the tensile stress increment on reinforcements.

The maximum force increments on soil nails at a depth of 0.5 m and 1.5 m are about 0.5 kN and 1.2 kN, respectively. The maximum forces on soil nails at a depth of 1.5 m and 4.5 m below the road surface following completion of reinforced earth embankment are 22 kN and 160 kN, respectively. The maximum force increment on soil nails caused by the 12-ton vehicle driving through uphill conditions is remarkably lower than the tensile force developed following the construction of the embankment. The maximum force increment on soil nails at 1.5 m below the road surface caused by the 12-ton vehicle is about 5% of that developed following the construction of the embankment. In addition, effect of driving at uphill and downhill conditions on the force increment of soil nails developed is not noticeable.

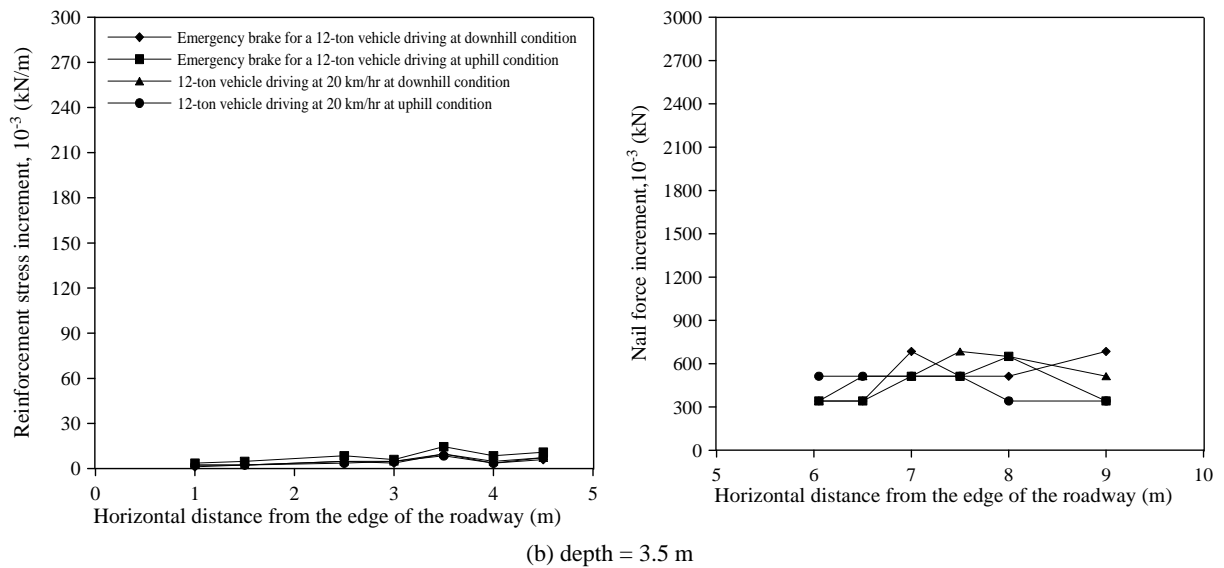
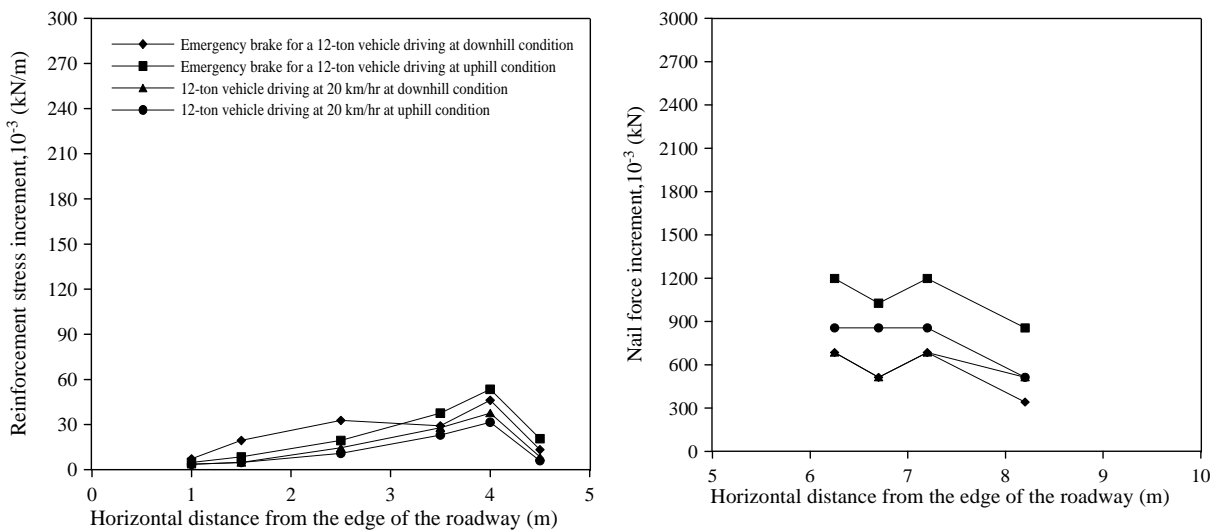
Fig. 12 Reinforcement (geogrid) stress increment and nail force increment induced by braking of 12-ton vehicles driving at 20 km/hr

**Fig. 12 Reinforcement (geogrid) stress increment and nail force increment induced by braking of 12-ton vehicles driving at 20 km/hr (continued)**

Emergency brake of moving vehicles results in a negative acceleration on the road surface. Thus, higher load amplitude on the roadway under emergency brake of moving vehicles can be expected in comparison with that caused by vehicles driving at a constant speed. Comparison of the stress/force increment of reinforcing materials induced by emergency brake of vehicles driving at a speed of 20 km/hr with that induced by vehicles driving at a constant speed of 20 km/hr is helpful in understanding the impact of driving conditions on the stresses developed in reinforcing materials. Shown in Fig. 12 is the monitoring result of the stress and force increments induced by emergency brake of a 12-ton truck driving through uphill and downhill conditions at a speed of 20 km/hr. In addition, monitoring results of the 12-ton truck driving at a constant speed of 20 km/hr through the uphill and downhill road conditions are also shown in Fig. 12.

The tensile stress increment on reinforcements and soil nails caused by emergency brake of moving vehicles is higher than that induced by vehicles driving at a constant speed. In addition, the stress increment on reinforcements caused by emergency brake at uphill conditions is greater than that at downhill conditions. The reinforcement at shallow depths developed a greater tensile force increment while driving at uphill conditions and pressing the emergency brake comparing with the results at downhill conditions. Greater force increments on soil nails were mobilized within 1 m below the road surface at braking conditions. The maximum stress increment on reinforcements at 0.5 m and 1.0 m below the roadway under braking conditions occurred at the end section of the reinforcement, with a value of 0.27 kN/m and 0.21 kN/m, respectively. Following the completion of the construction of the embankment, the maximum tensile stress on the reinforcement at 1 m below the road surface was 3.6 kN/m, and the maximum tensile force increment on the reinforcement caused by braking was about 6% of that following the construction. For 12-ton truck driving through uphill conditions

at a constant speed of 20 km/hr, the maximum tensile force increment on the reinforcement at 0.5 m below the road surface was about 0.15 kN/m. This value is about 55% of that induced at braking condition.

The tensile force increment caused by braking of vehicles during driving conditions at the front of the soil nails, *i.e.* near the connection between soil nails and reinforcements, was noticeably mobilized compared with that at the central and back portions. In addition, the force increment of soil nails induced by braking of the 12-ton truck at shallow depths is greater than that at greater depths. The maximum force increment of the soil nail at 0.5 m and 1.5 m below the road surface occurred at its front end, with a value of 2.1 kN and 1.2 kN, respectively. These values are greater than that induced by vehicles driving at a constant speed (20 km/hr). The maximum tensile force at 1.5 m below the road surface following the completion of the construction of the embankment was 22 kN. Therefore, the maximum force increment on the soil nail at 1.5 m below the road surface induced by braking of 12-ton vehicle was about 5.5% of that following the completion of the embankment.
