REHABILITATION OF DAMAGED SOFT GROUND TUNNELS

ABSTRACT

The paper presents the rehabilitation of soft ground tunnels that were damaged in an accident at the ventilation shaft A of the Pan-chiao Line of Taipei Rapid Transit Systems. Subsoil conditions and the preceding operations at the tunnel-shaft interface are introduced. The accident at shaft A is described and ground settlement data induced by the accident are presented. Procedures taken by the contractor during emergency rescue, damage assessment, and rehabilitation of shaft and tunnels are reported. Possible reasons that caused the accident included drift wood in the ground, cleavage between soilcrete and shaft, and non-verticality of grouting rods. It is concluded that the ground improvement outside the shaft before the shield's arrival played an important role in this accident. The geotechnical engineer should be extremely cautious when breaking the mirror-face on the diaphragm wall under the threat of high groundwater pressure.

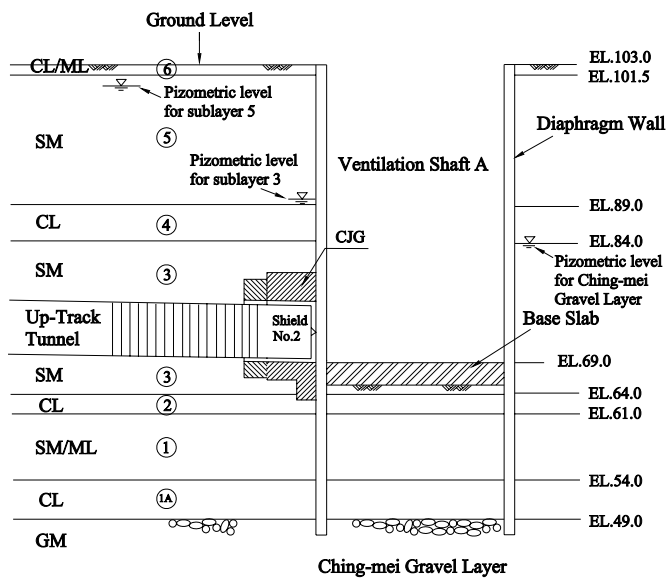
Fig. 2 Subsoil conditions (redrawn after Ju *et al.*, 1997a)

Figure 1 shows the ventilation shaft A was only 340 m west of Hsin-tien Creek. The shaft is a 25.9 m-long, 25.4 m-wide sub-surface structure. Figure 2 shows the sides of the shaft were made of 1.2 m-thick, 55 m-deep diaphragm walls, which penetrated 3 m into the Ching-mei gravel layer. During the excavation of the shaft, deep-well pumping was executed to reduce the pore pressure in Ching-mei gravel layer. So that no heaving or boiling would occur at the bottom of excavation due to the artesian pressure in the underlying gravel layer.

Due to the existence of the cohesive sublayer 4, two ground water tables (GWT) were observed in the Sung-shan Formation. In Fig. 2, the perched GWT in the sublayer 5 is at about 3 m below ground level. However, the pressure head measured during shielding tunneling in the sublayer 3 was located at the elevation of 89.5 m. This was the GWT that caused the accident, and this was the GWT to pay attention to during the rehabilitation of the damaged tunnels.

The ground subsidence was induced by piping of soils into the shaft. The inflow of mud was driven by the tremendous pressure head in sublayer 3 indicated in Fig. 2. Under such a high hydraulic gradient, the groundwater was pushed to seep through some fissures and entered the shaft. To stop the mud inflow, it would be necessary to balance the water pressure inside and outside of the ventilation shaft.

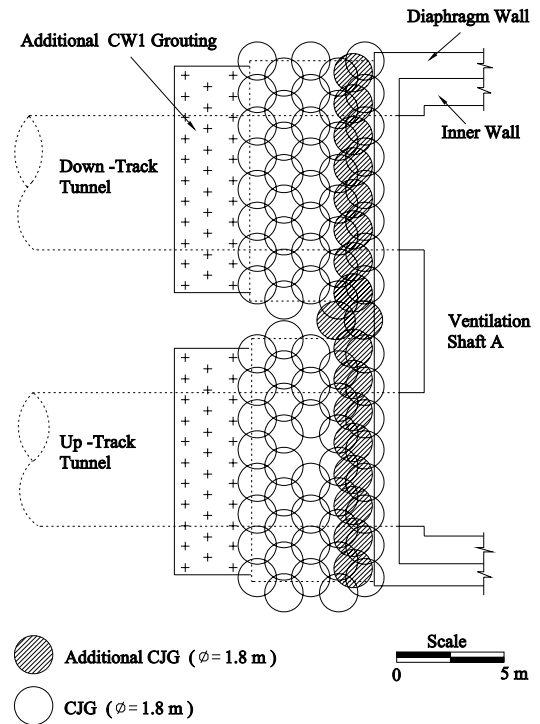
Fig. 3 Ground improvement at shaft A before accident

Figure 3 shows the arrangement of ground improvement outside shaft A before the shield machines arrived. For the up-track tunnel, a total of 40 CJG columns were grouted in 5 rows. Each soilcrete column had a diameter of 1.8 m. The centers of columns were arranged in triangular formation with a center-to-center spacing of 1.54 m. The 40 overlapped columns were supposed to form a rectangular soilcrete block next to the tunnel-shaft interface. Since the width of the soilcrete block 6.27 m was slightly less than the length of the EPT shield (7.68 m), an additional 3.0 m-long CW1 grouting zone shown in Fig. 3 was conducted. The composition of CW1 grout is indicated in Table 2. The CW1 fluid is an inorganic fast-set silicate sodium grout additive. It is added to the CW1 grout to enhance the watertight characteristics of the improved ground. The permeation grouting with the CW1 grout could effectively fill the voids among soil particles. With this arrangement, the shield machine can be fully protected by the improved ground when waiting to enter the shaft.

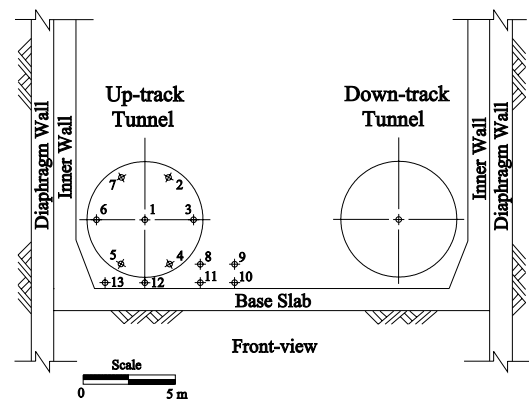
Fig. 4 Borehole location for leakage tests

ground under pressure. When encountering water, the OHA agent will foam and expand in about 4 minutes to fill all the voids in the cleavage and to block the flow channel of groundwater. For the second test, bore holes were drilled 1.1 m into the soilcrete and inflow was measured at holes 3, 4, 5, 8, and 9. The maximum rate of inflow was 170 l/min. It was obvious that some flow channels existed. As a result, one additional row of CJG columns shown in Fig. 3 was grouted. For tests 3 and 4, the bore holes were penetrated 3.1 m into the soilcrete. Following the construction of the extra row of CJG executed from 24.99 to 40.33 m below ground surface, no more groundwater inflow was observed.
