EVALUATING WEAK SUBGRADE FOR PAVEMENT DESIGN AND PERFORMANCE PREDICTION: A CASE STUDY OF US 550

ABSTRACT

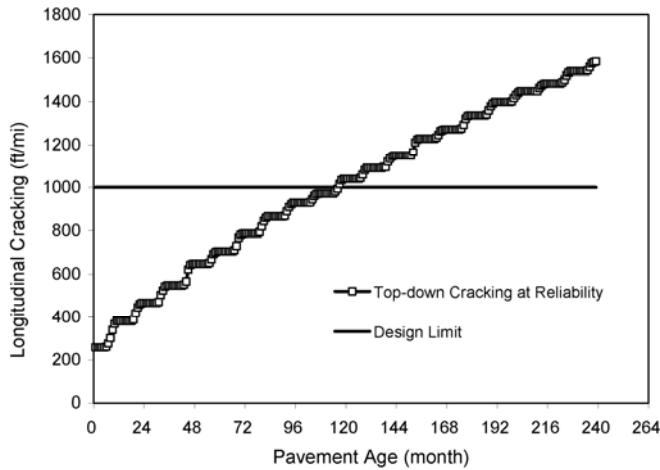
Fig. 3 Top-down cracking in Sections 1 and 2 of US 550 (MEPDG analysis with subgrade R-value = 12)

The MEPDG outputs are expressed in terms of distresses such as rutting, top-down longitudinal cracking, fatigue cracking, etc. In addition, pavement smoothness is considered through the International Roughness Index (IRI). In the MEPDG analysis, the target values of these distresses as well as their reliabilities are defined as inputs. In the present analyses, the target distresses were set for AC rutting = 0.25 in, total rutting = 0.75 in, IRI = 172 in/mi, fatigue cracking (bottom-up) = 100%, and top-down cracking (longitudinal) = 1000 ft/mile with a reliability value of 90% (MEPDG, 2007). The simulation outputs of the aforementioned three analyses are summarized in Table 6. It is evident from this table that the predicted distresses are well below the target distresses except for top-down cracking. Permanent deformation, bottom up cracking, and IRI of US 550 are in tolerable limit. Eight among nine simulations failed due to top-down (longitudinal) cracking. For all the failed cases, reliability is less than 90% or the top-down cracking exceeds the target value of 1000 ft/mile. Therefore, from the MEPDG analyses, it is evident that the existing design of pavement structure of US 550 is not adequate for top-down cracking along the wheel path. From the right most column of Table 6 indicates that sections 1 and 2 of US 550 will fail at the age of 9.75 years. To better illustrate this, the MEPDG output of the progression of top-down cracking of sections 1 and 2 is plotted as a function of time in Fig. 3. It can be seen that the predicted top-down cracking exceeds the target value with 90% reliability at the end of 9.75 years.

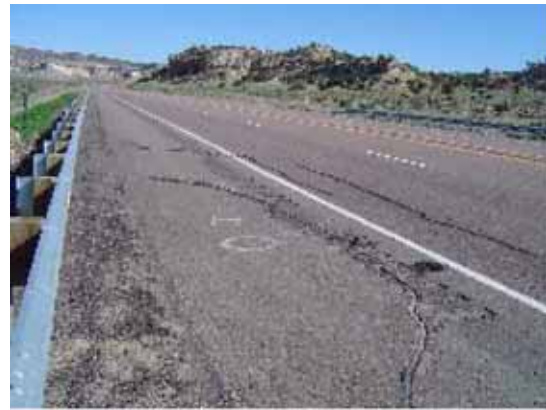
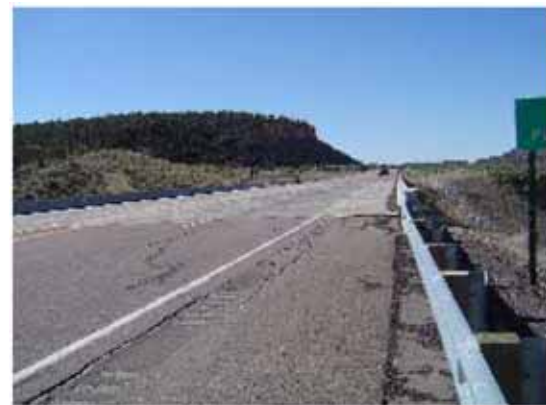
Fig. 4 Top-down longitudinal cracking pavements and shoulders

(a) Section 1: MP 49

(b) Section 2: MP 52.7

Four site visits were made to document the field conditions of the US 550. The purpose of these field trips was to study six sections of US 550 through visual inspection and photographic documentation of pavement distresses. Figure 4(a) shows surface down or top-down longitudinal cracking observed on section 1, which is close to MP 49 or approximately 25 miles north of the US 550 southern project limit. This cracking is on the southbound lane. Geotechnical investigations at this site specifically close to MP 49 revealed that the embankment material had some clay content, and high plasticity. The SPT blow count N values are relatively low. Figure 4(b) was taken from section 2 near MP 52.7, where the bridge over the Rio Puerco begins. This figure shows pavement cracking on the southbound approach to the bridge. Geotechnical data reveal that the soil characteristics near MP 52.7 are highly variable. About 24% of the field density values are above 95% but below the specification requirement of 100%. However, it is not possible to correlate the density data with the pavement surface cracking. The US 550 is currently at the age of 6 year (opened 12/8/2001). However, from the field visit, it was evident that most of the US 550 sections exhibited low to moderate top-down longitudinal cracking along the wheel paths in both directions. According to New Mexico Department of Transportation, a top-down longitudinal crack will be considered as low severity cracking when it has a mean width of less than 1/4-inch and minor spalling. A moderate severity top-down longitudinal crack will show moderate spalling or allow water to penetrate or be over 1/4-inch wide or cause significant bump to a vehicle. A high severity longitudinal crack will be severely spalled or will show high severity fatigue (alligator) cracks near and/or at the corners of intersecting cracks or causes a severe bump to a vehicle (NMDOT, 2007). During the field visits, the top-down longitudinal cracks were ranked low to moderate based on minor spalling and significant bump to the vehicle. Overall, the results of MEPDG matches with the top-down cracking measured during the field investigations in this study.

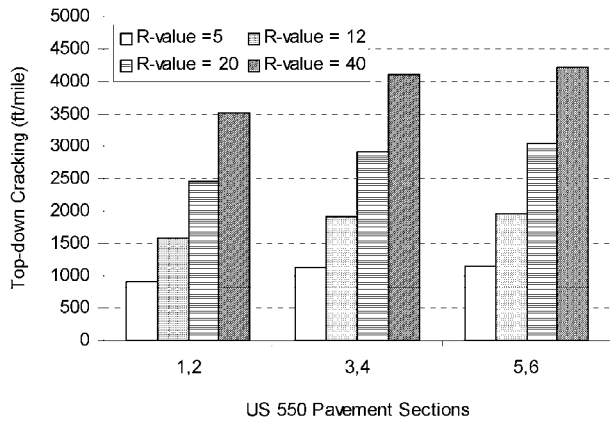
Fig. 5 Effect of R-value on top-down cracking

software. The predicted top-down cracking is shown in the bar chart shown in Fig. 5. It can be seen that the top-down cracking is close to or above 1000 ft/mile (limiting value) irrespective of low or high R-value. This indicates that subgrade weakness/strength may not be responsible for top-down cracking. It may be due to stripping, asphalt binder aging, cold temperature work, perpetual pavement design or possibly the mix design, which is beyond the scope of this study (Svasdisant, et al., 2002; Wang, et al., 2003; De Freitas, et al., 2005).

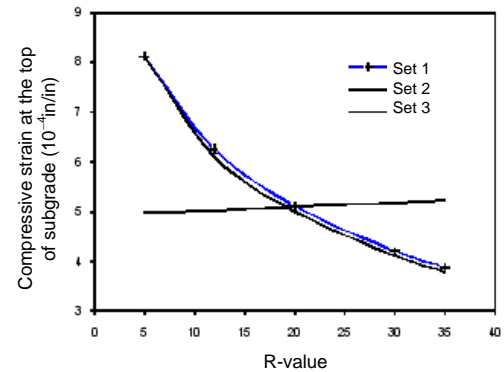
(a) Compressive strain vs. R-value

(b) Vertical displacement vs. R-value

Fig. 7 Effect of R-value on subgrade strain and displacements (elastic analysis)

Figure 7(a) shows the compressive strain at the top of the subgrade in all three sets. Compressive strain decreases at an equal rate in Set-1 and Set-2 pavements with the increase in R-value. This is because pavements Set-1 and Set-2 have equal R-values for the top subgrade layer. In Set-2 pavements, the bottom subgrade layer with an R-value of 5 has little or no effects on the strain at the top of subgrade. When R-values are smaller than 20, compressive strains in Set-3 pavements are smaller than those in Set-1 and Set-2 pavements. This illustrates that subgrade treatment is very useful in controlling compressive strain level. Vertical displacements of subgrades in the three pavement sets are presented in Fig. 7(b). It can be seen that the vertical displacement decreases with the increase in R-value. The weak bottom subgrade layer (R-value = 5) has contributed to high vertical displacement in Set-2 pavements. This means that the weak soil below a subgrade (12 in) is a concern for high deformation. Subgrade vertical displacement curves of both Set-3 and Set-1 decrease rapidly with the increase in R-value up to 17. The increase in subgrade vertical displacement is very small flat when R-values are greater than 17. In this region, added strength of subgrade contributes a little to reducing subgrade vertical displacement. Therefore, an R-value of 17 can be a cut-off value to differentiate weak from strong subgrade. The pavement designers can develop similar relationship for other subgrade/pavement combinations.
